**DEITZ COMPANY, INC.**  
**ROUTE 34, WALL, N.J.**

PRODUCT	CS1 VERSION 3.0	BY	SJD2	DATE	4/2/01
TITLE	TROUBLESHOOTING	SHEET	1	OF	1
	COTTONNER FIRES ONCE AND STOPS	NUMBER	TN0051	REVISION	-
	CYLINDER SENSOR ADJUSTMENT

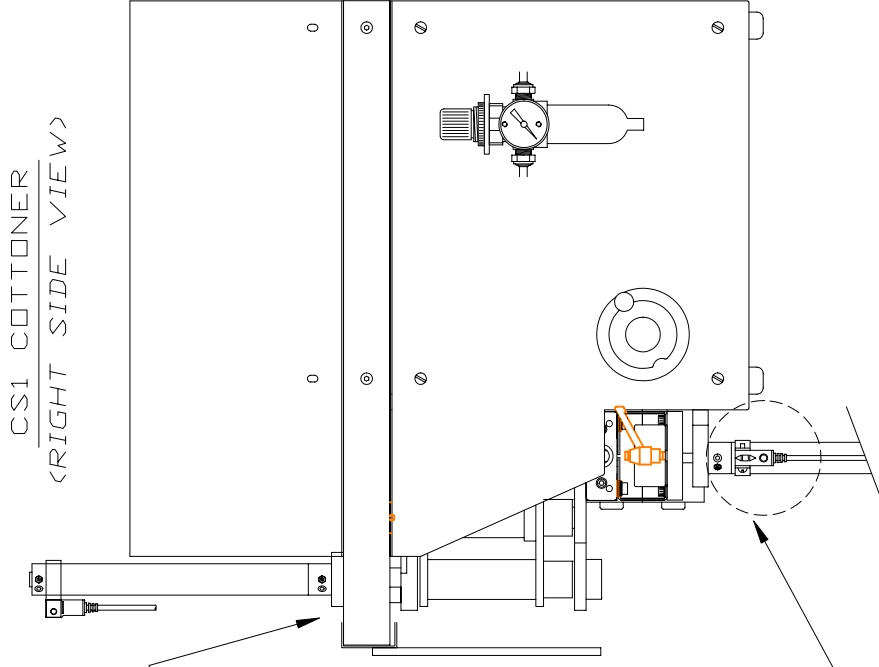
CS1 COTTONNER  
(RIGHT SIDE VIEW)

IF THE INSERTION ROD EXTENDS ONCE AND MACHINE FREEZES IN THAT POSITION, THE COMPUTER CONTROL MAY BE UNABLE TO TELL THAT THE LOWER CYLINDER IS FULLY EXTENDED.

LOOK AT THE POINT WHERE TO COTTON IS PUSHED OUT INTO THE BOTTLE. IF THE WHITE PLASTIC PLUNGER IS VISIBLE, THIS IS THE PROBLEM.

RAISE THE MACHINE UNTIL YOU CAN SEE THE LOWER CYLINDER. LOOK AT THE LOWER CYLINDER SENSOR. IF A GREEN LIGHT IS NOT SEEN, DO THE FOLLOWING.

FIRST YOU MUST BE SURE THAT COTTON IS NOT JAMMED IN THE TUBE (THIS IS RARE, BUT DOES HAPPEN).

TURN OFF THE POWER (PRESS STOP). THE RODS SHOULD WITHDRAW. NOW LOOK INTO THE OBSERVATION HOLE ON THE TOP OF THE TURRET SUPPORT WHILE ROTATING THE TURRET BY HAND. IF THE TUBES ARE NOT PACKED WITH MULTIPLE PIECES OF COTTON, THE LOWER CYLINDER SENSOR MAY NEED TO BE ADJUSTED.

POWER ON AND PRESS THE BUTTON MARKED "EXTEND RODS". USE A PHILLIPS SCREWDRIVER TO LOOSEN THE BAND THAT HOLDS THE SENSOR AROUND THE LOWER CYLINDER. SLIDE THE SENSOR UP OR DOWN A SMALL DISTANCE UNTIL THE GREEN LIGHT TURNS ON AND STAYS ON. TIGHTEN THE CLAMPING BAND TO HOLD THE SENSOR IN THIS POSITION.

PRESS "EXTEND RODS" AGAIN AND THE MACHINE SHOULD OPERATE NORMALLY.
